# GOD SAVE THE KING

## THE AUTOMATON SHIP AND SILVER SHAGREEN CASE

*The West Dean College Conservation of Clocks and Related Dynamic Objects Department received a small musical automaton movement for conservation work in October 2011. The owner requested a case be made for it and the mechanism be restored to working order. Consultation with English and European conservators, museums and collectors, and a literature review, revealed no knowledge of any other object of this type.*

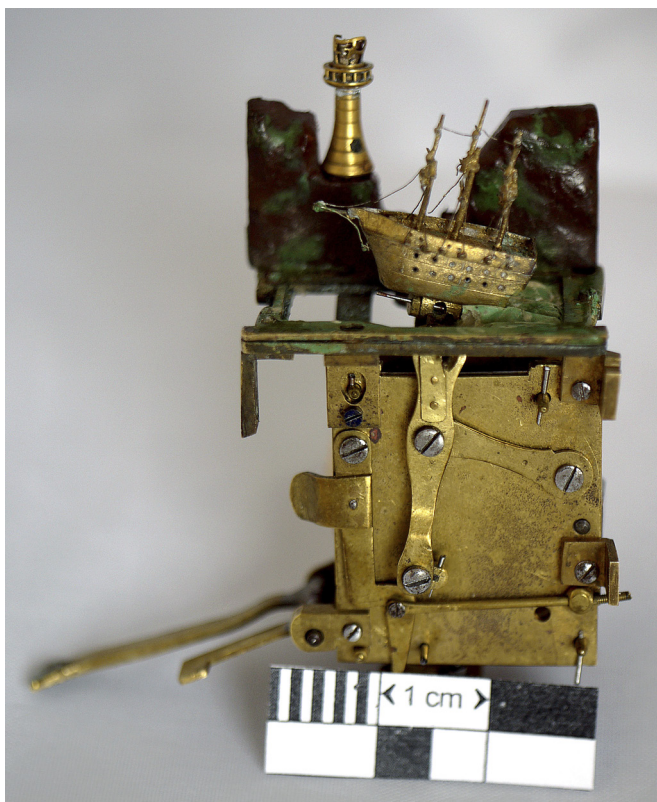
Fig. 1. The mechanism as received

The small mechanism (Fig. 1) controls a three dimensional nautical scene containing a gilt lighthouse set on cliffs of green and brown painted wood, and a gilded ship resting on a painted sea in front of the cliffs. The ship rocks to and fro, as though in a storm, while a tune plays on a plucked comb.

The musical component of the mechanism was not in operational order. There were many compounding faults that resulted in a lack of resonance from the comb when plucked by the pins on the musical barrel. The movement was previously separated from its case and no records remain of its former arrangement. Therefore, the design and construction of a case for the mechanism could not be guided by other examples. After discussions with the owner, silversmith John Norgate, and clocks department tutor Matthew Read, a case was designed to suit the period during which the object was made, as well as the needs of the owner. It would be made of silver, in a size and shape comfortable for one's pocket.

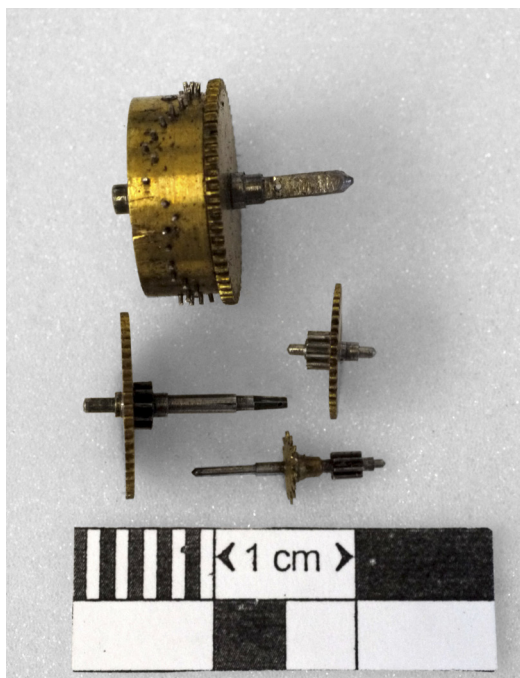
Fig. 2. The train

Restoring the mechanism to working order was by far the most challenging aspect of the project, and discussion with assistant clocks tutor Malcolm Archer aided in the development of a plan for conservation treatment. The movement has four cylindrical pinned pillars and rectangular brass plates that enclose a five-

Train Count	Teeth	Pinion Leaves
Barrel	50	
Intermediate wheel	50	10
Second intermediate wheel	40	10
Worm gear	16	8

component train, governed by a fly and worm gear (Fig. 2 and table).

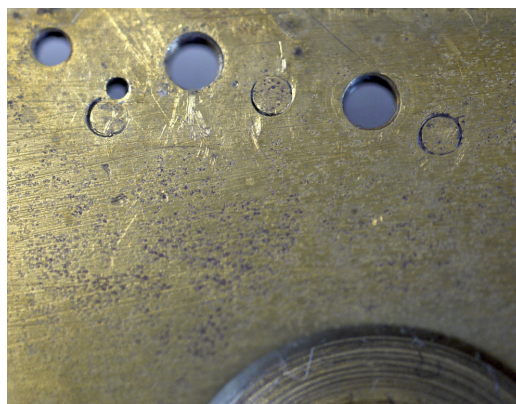
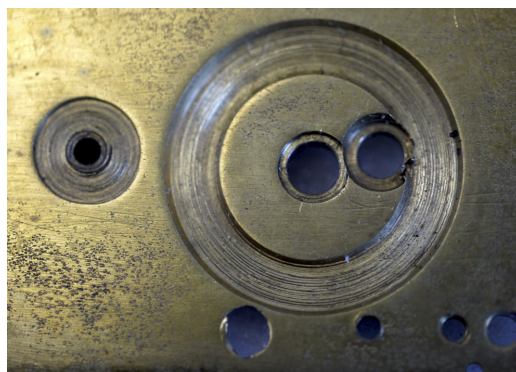
Recesses for the gear train and oil sinks are reminiscent of those seen in watch manufacture. There is a series of plugged and empty holes, indicating that the plates may have been adapted from an earlier purpose, or perhaps that things were moved around (Figs 3 and 4).

Fig. 3. Plugged holes

Fig. 4. Watch work recess

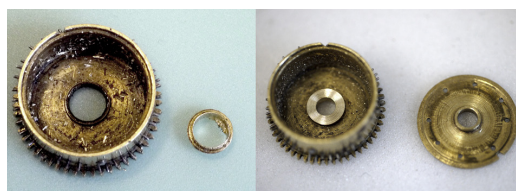
Fig. 5. Barrel bushing

Among the many faults in the mechanism, the mainspring was slipping inside the barrel, and the hook had to be filed away underneath to provide a surface on which the eye could catch. The barrel cap and body, as well as the top and bottom barrel main plate bearings, were worn, making the barrel run out of true. This caused a misalignment between the music pins on the barrel and the teeth of the comb.

Tolerances for the barrel, due to the position of the pins in relation to the comb, are very small. After the barrel and bearings were bushed (Fig. 5), the position of the comb had not

improved enough for the pins to run in line with the comb teeth. The comb did not sit flat, but at an angle. Minimal material was removed from the base block by filing it flat and a brass spacer was made to raise the comb teeth level with the pins.

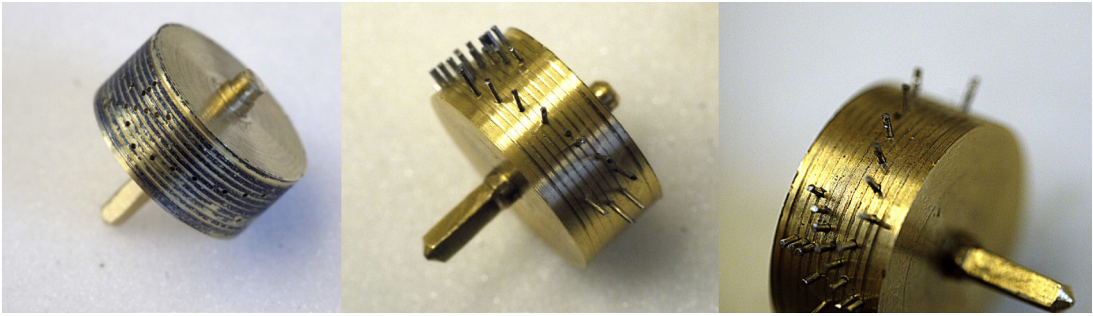
Fig. 6. Test barrel

Further problems with the music component included the fact that the comb had lost its resonance due to two teeth rubbing at the base. The tone of each was restored by the fractional removal of material at the base of the two teeth. The comb was tested for resonance separate from the mechanism and each note rang out clearly, but the comb remained silent when plucked by the barrel. This could have been the result of numerous factors such as the angle at which

the pins on the barrel engaged the comb, or the shape and height of the pins. A test barrel was made with different types of pins, varying in height, angle, and shape. (Fig. 6)

When the test barrel was placed into the mechanism, a set of long, flat-topped pins played most clearly and resonantly by comparison with others that were tested. In light of this, repinning the barrel was considered, but the risk seemed too high to justify the procedure, and plans to make a new barrel developed. A music map of the tune was prepared and, entering the map into a music-making programme along with the specific tones of the comb, the tune on the barrel was revealed to be 'God Save the King'.

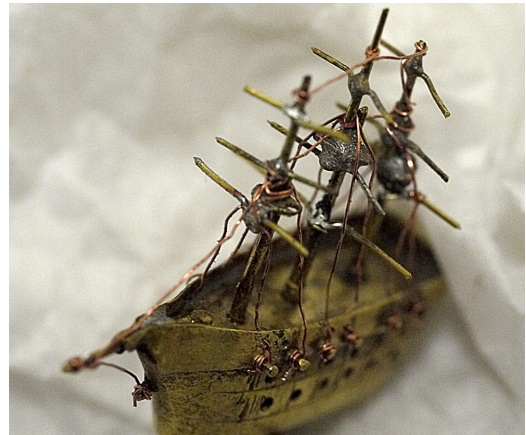
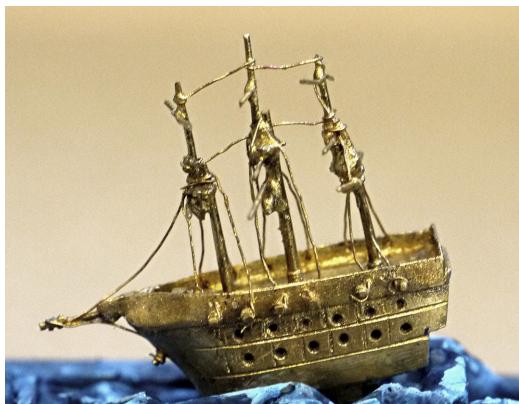
Fig. 8. Repaired rigging and mast

Fig. 9. The ship after restoration.

Sections of the masts and wire rigging on the ship were missing, so brass wire was drawn down to the appropriate size in order to replace the missing masts. The wire rigging was then redone with fine copper wire. The ship, new masts, and rigging were gilded (Figs 8 and 9).

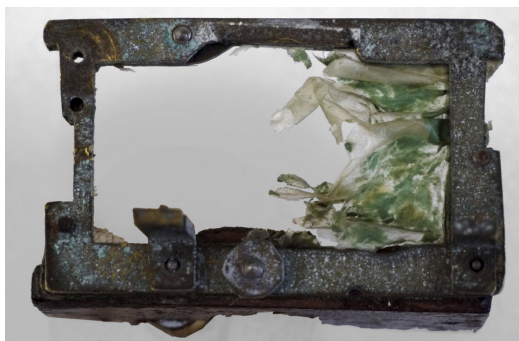
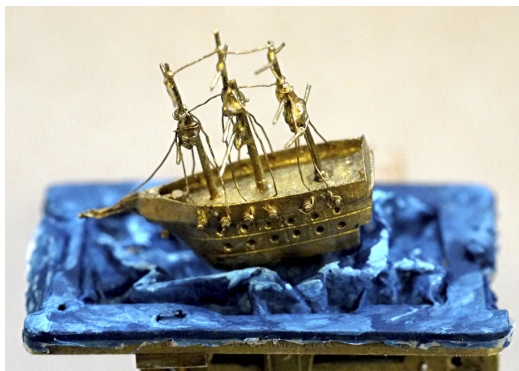
Fig. 10. The sea underneath

Fig. 11. New sea

Half of the original sea material was missing, having been comprised of isinglass, dried fish bladder that is used for a variety of purposes

including confectionary and brewing. This was replaced with new isinglass and painted to resemble the sea from a traditional ship in a bottle. Techniques were borrowed from art conservation practice and Paraloid B-72 Retouching Gels<sup>3</sup> were used to paint the new isinglass sea. The B-72 based paint is removable with acetone and should not affect the brass over time on which the sea is secured (Figs. 10 and 11).

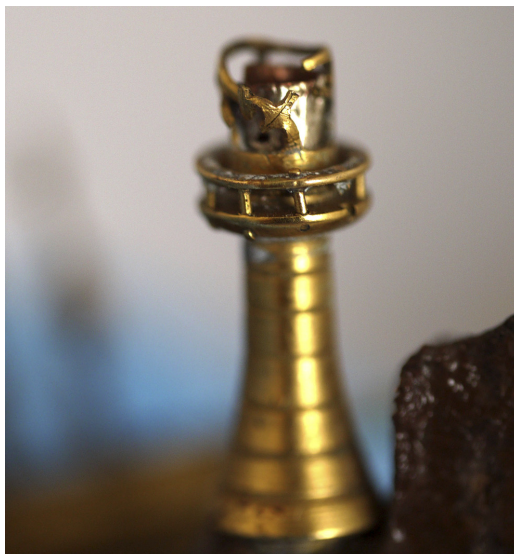
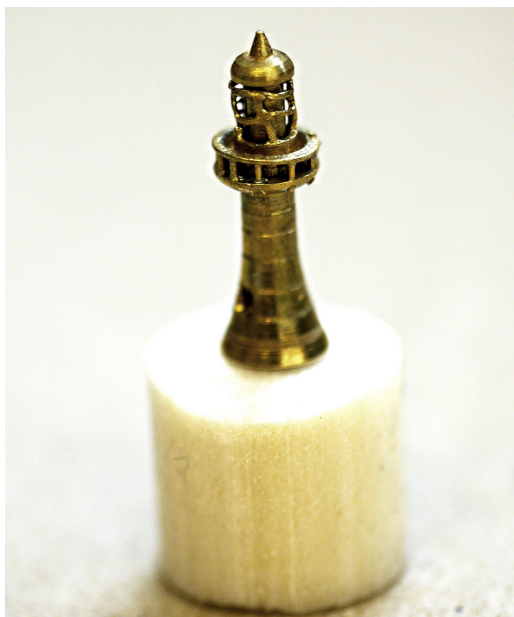
Fig. 12. Lighthouse foil and break

Fig 13. Lighthouse and top

The fine gold fretwork on the lighthouse was straightened, as much of it had caved in and a replacement top for the lighthouse was turned from brass to match designs of the period. The fine silver foil that gives the lighthouse the effect of luminosity was reinserted under the fretwork. Both the new top and lighthouse were gilded (Figs 12 and 13).

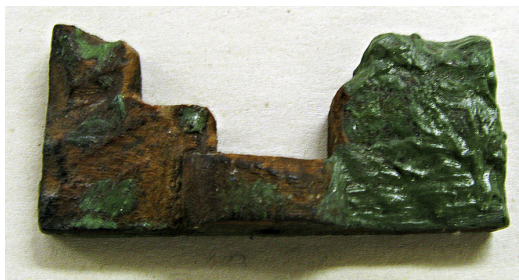
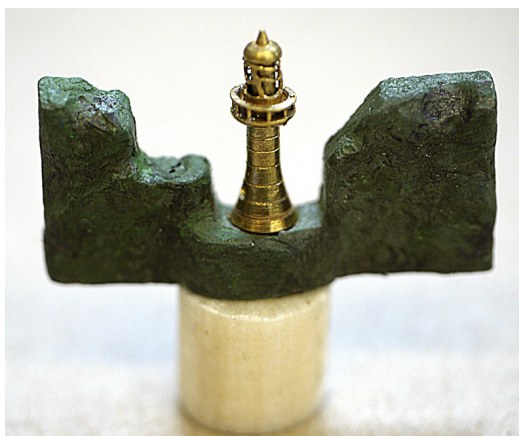
Fig. 14. Retouching the cliffs

Fig. 15. Lighthouse and cliffs after restoration

The later brown lead paint from the wooden scenery was removed and the earlier dark green paint was preserved using the Retouching Gels. The original green paint was left uncovered and can be distinguished from the new Paraloid based paint, as the original is darker in colour (Figs 14 and 15).

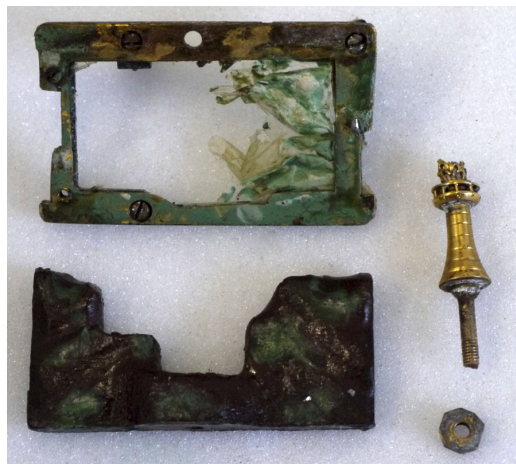
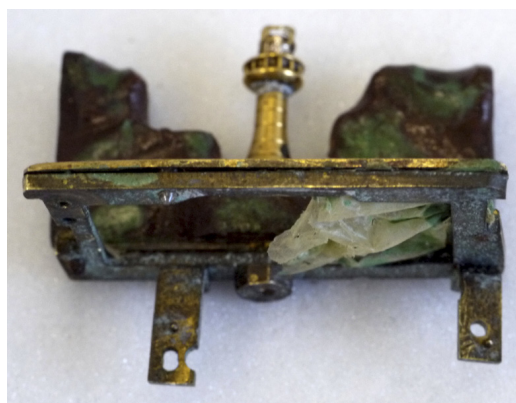
It became apparent that the lighthouse was originally located in the central recess and had been moved to the higher position on the cliff. The screw at the bottom of the lighthouse is the exact same length as the screw that was used to hold the plates together, the base of the lighthouse fits snugly in the central recess, and the nut used to secure the plates fits the lighthouse. It was decided the safest place for the

Fig. 16. The lighthouse disassembled

Fig. 17. Screw evidence

lighthouse is the central recess, as the later hole is a loose fit and the lighthouse is not secured to the wood. The later hole was painted over with the Retouching Gels (removable with a touch of acetone) and the lighthouse was returned to its central location (Figs 16 and 17).

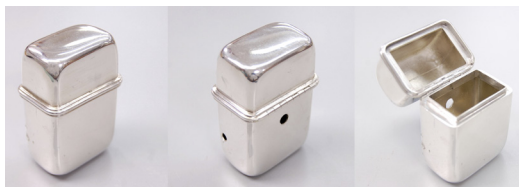
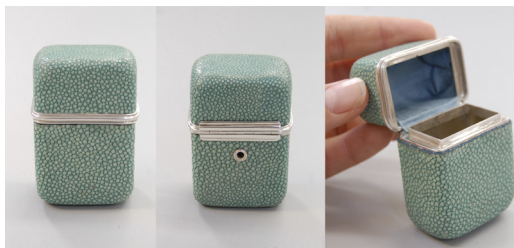
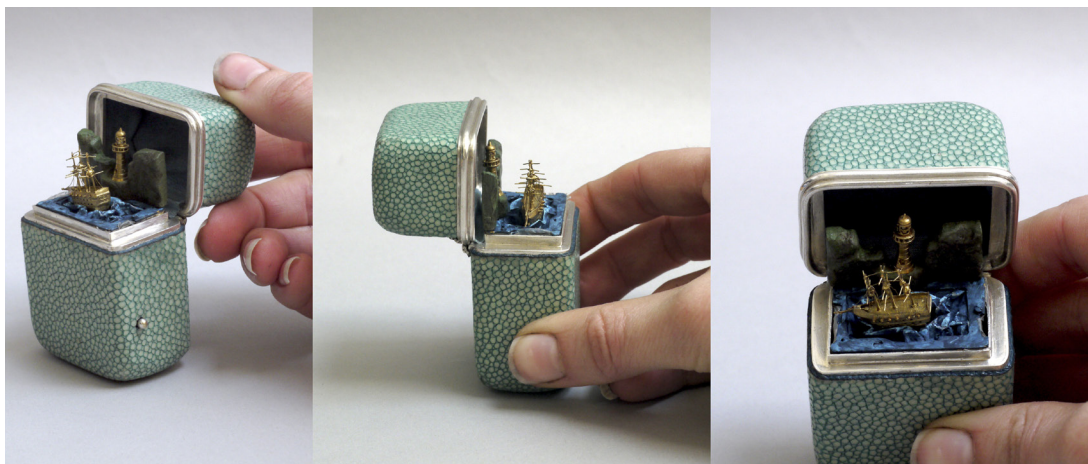
Fig. 18. Silver case

Fig. 19. Shagreen case

Fig. 20. The ship in the case

A cushion shaped case was handmade from sterling silver sheet and covered in shagreen, its lid lined with nineteenth-century blue silk provided by the owner. The nine-piece joint was designed to be internal to a reeded wire that would frame the lid of the case. Once the case was polished and finished, collaboration with the West Dean Conservation of Books and Library Materials Department made it possible to cover the case in shagreen. Cases of 1810 were researched and a shagreen distributor was identified in London.<sup>4</sup> Traditional shagreen was chosen and books student Abigail Uhteg covered

the case. The case was made to suit existing screw holes in the mechanism. The mechanism was fitted into the case after the addition of a start/stop button and spring, winding bezel, and hinge safety lock (Figs 18, 19 and 20).
